Cordova, Recreation & Park District Cordova Community Pool Evaluation

May, 2014

*Prepared by:
Aquatic Commercial Consulting
Richard A. Young, Aquatic Consultant
800-660-5202 // richy@aquacom.us*

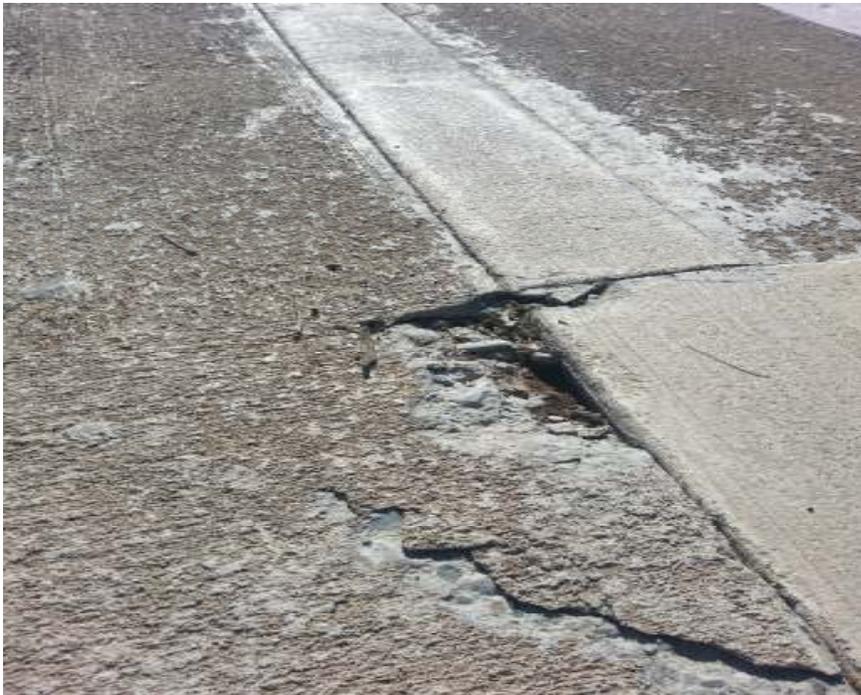
- A. There are number of deck areas with unsightly stains or failed concrete areas. Several areas present a trip hazard and are not in compliance with CHSC. PP-1, 2

PP-1 Failed Deck Areas

-Eliminating or minimizing tripping hazards (concrete patches, ledge grinding etc.)	\$ 2,000
-Install new ramps with proper slopes to comply with Federal ADA.	8,000
-Revitalizing deck safety signage (even painted signs)	500
-Install anti-siphon devices on the hose bibs	300
-Move or replace the underwater junction box to be compliant	200

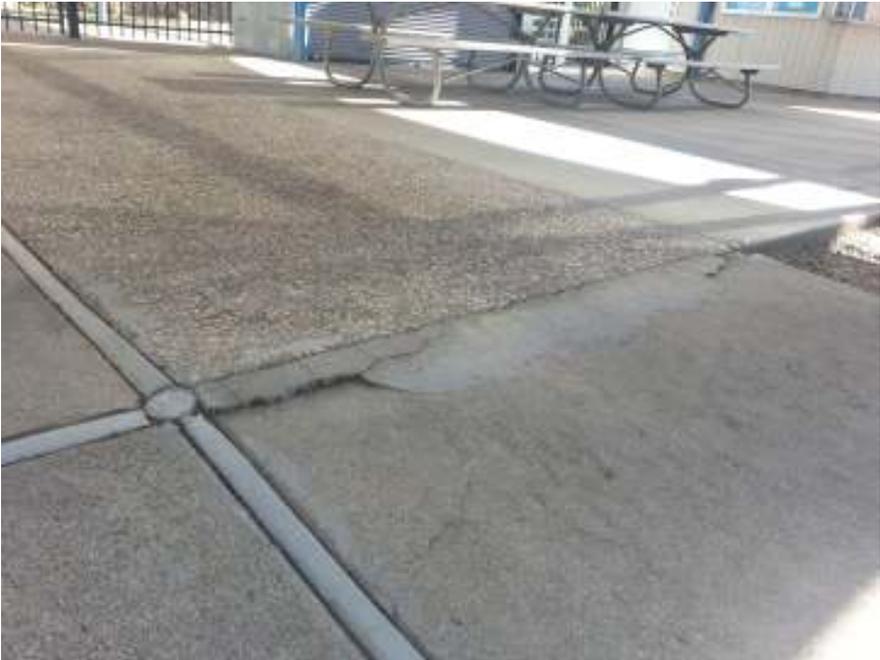
- B. Several deck areas have wood screeds that have rotted or have become depressed again, presenting a trip hazard. Many have been replaced with concrete. CHSC, PP- 2, 3

PP-2 Deck Sections, Replaced Screeds

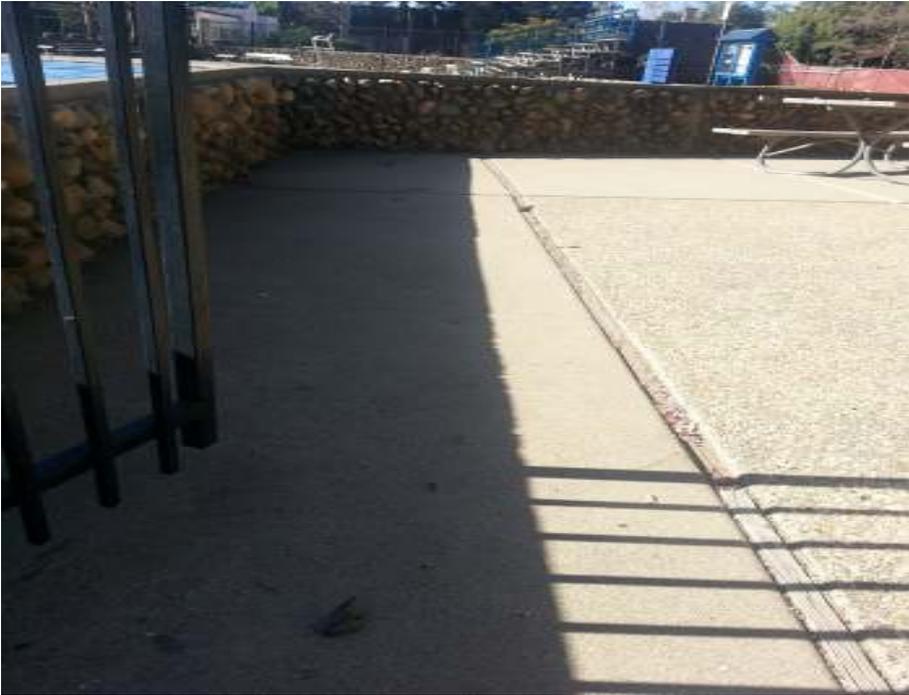
PP-3 Old Wood Screeds at Entry

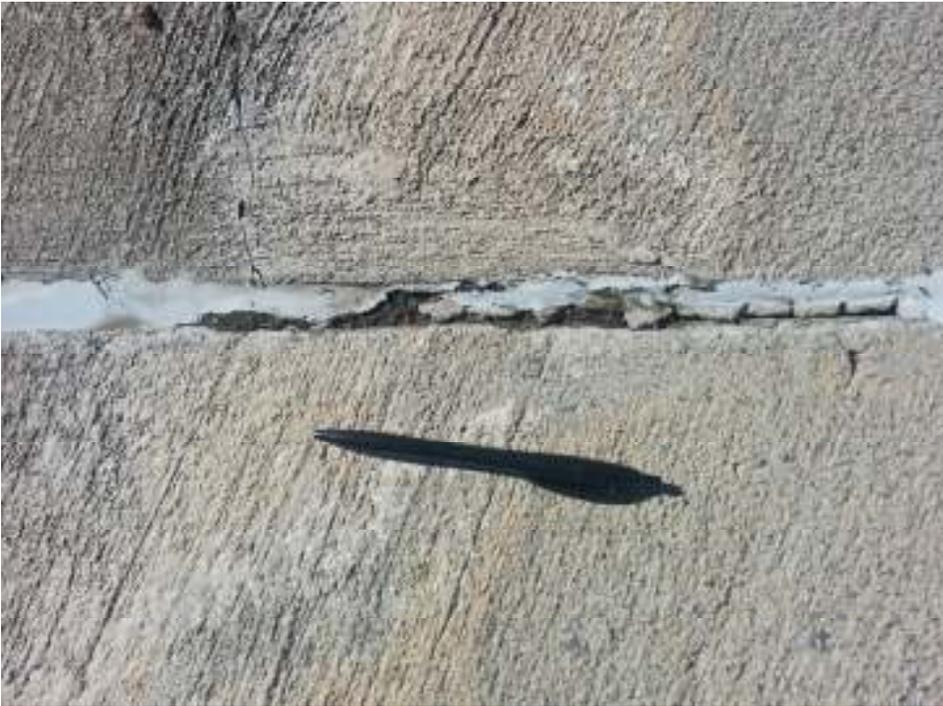
- C. The expansion joints throughout the deck have failed. PP- 4, 5
- D. There are abandoned in-deck light junction boxes that remain along with old racing starting platform anchors which are well below the deck surface and present a trip hazard. CHSC, PP-6

PP-4 Failed Expansion Joints

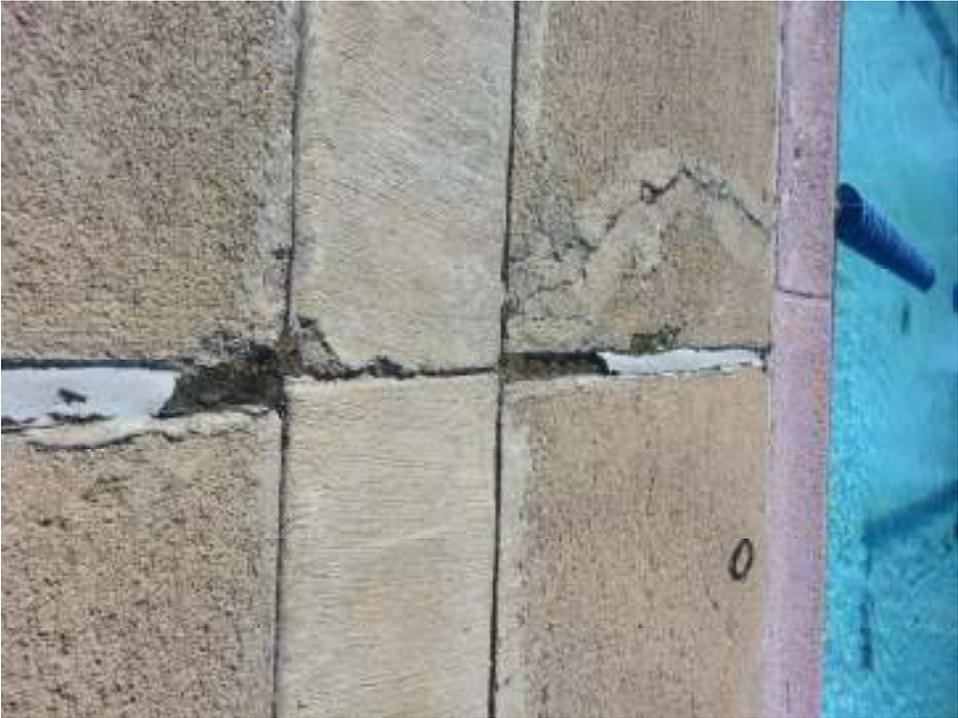
PP-5 Failed Expansion Joints -2

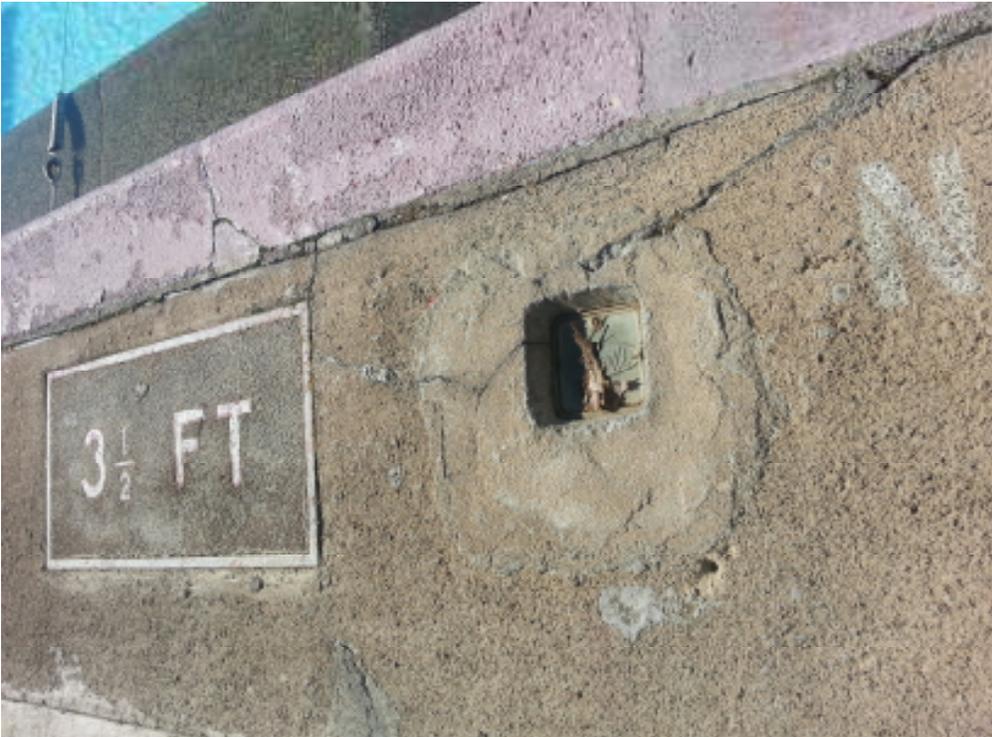
PP-6 Abandoned Deck Anchors Boxes and Expansion Joint

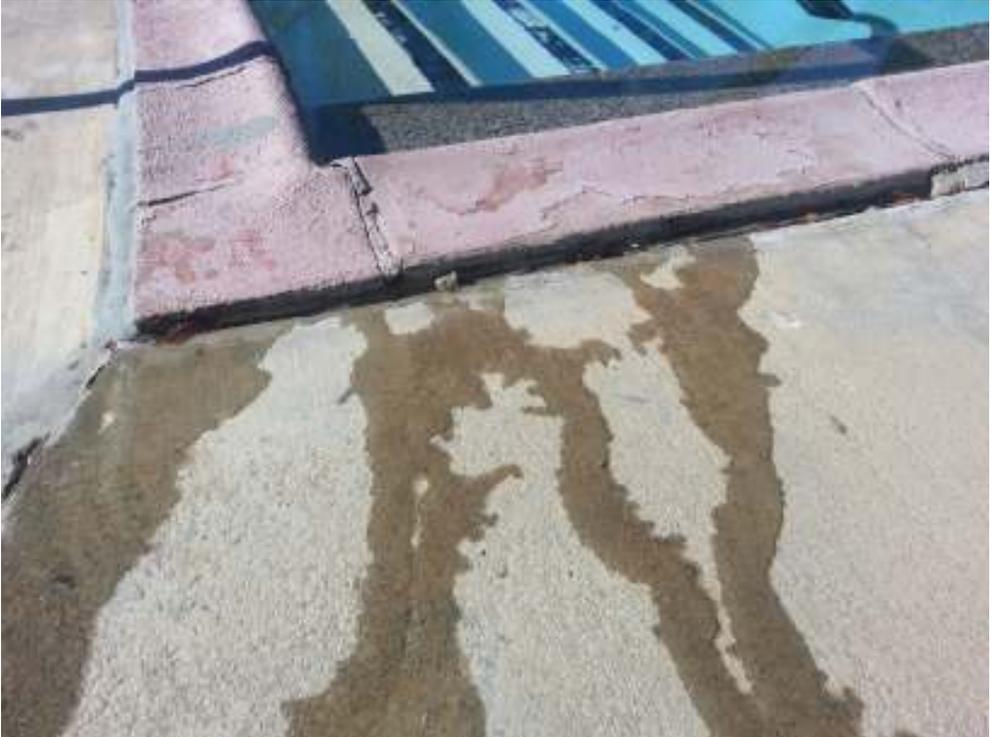
- E. There are several areas where the deck and the pool edge coping stones are not the same elevation and present a trip hazard. CHSC, PP-7
- F. Staff reports a numerous areas around the deck will have standing water. There are various area deck drains with various slopes to various deck sections. Standing water is not compliant with CHSC. PP-8

PP-7 Trip Hazard at Pool Edge Coping, Failed Expansion Joint, Leak

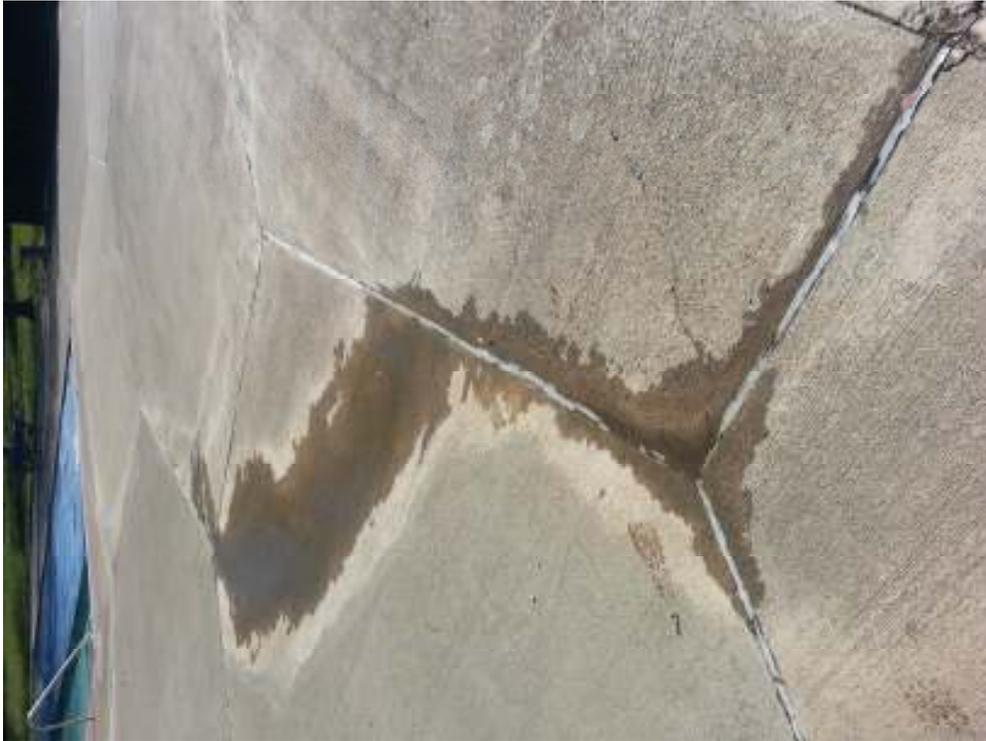
PP-8 Standing Water

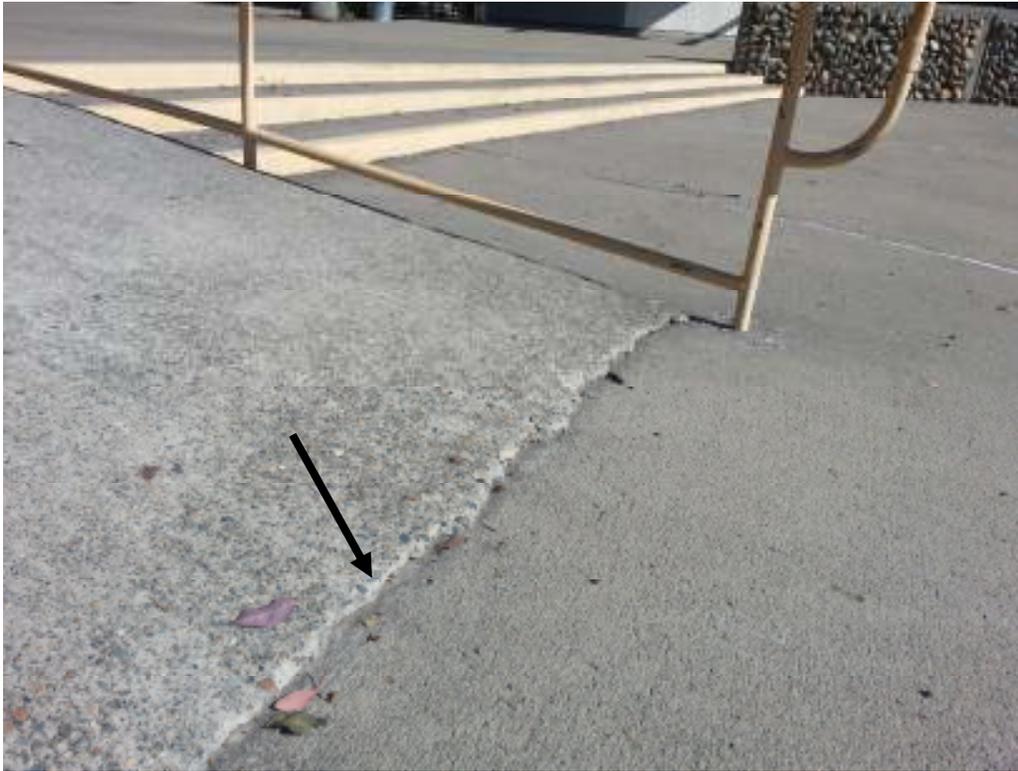
- G. The ramp on the north side of the lap pool has a 6% slope. CHSC and Federal ADA call for no more than a 1% slope. This ramp also has a considerable ledge of near 1". PP-9
- H. The ramp between the lap pool and the diving pool has a slope near 7% and falls well short of CHSC and Federal ADA. Code. PP-10
- I. The deck ends with an unprotected curb behind the bleachers with a near two foot drop off. The ledge between the lap pool and the diving pool does have a protective rail. The curb is breaking down and steel rebar is exposed. PP-11
- J. The step areas adjacent the ramps described above must have rails on both sides to comply with Federal ADA and building code. PP-10

PP-9 Slope on Ramp, Ledge

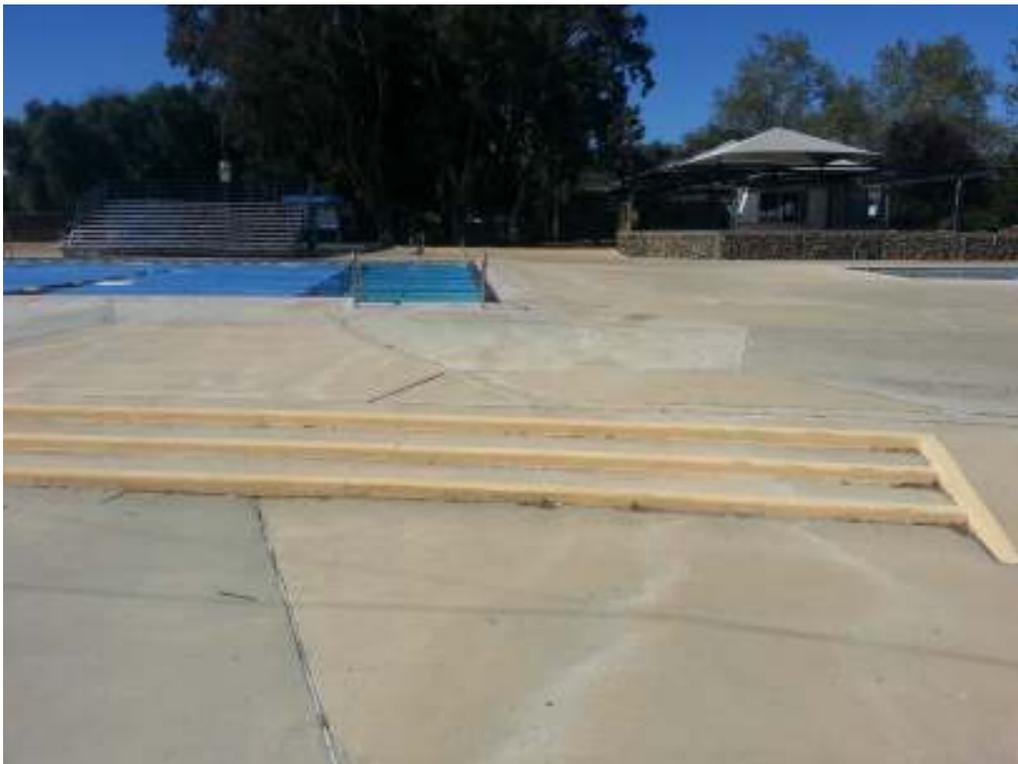
PP-10 Steps without rail, Ramp too steep

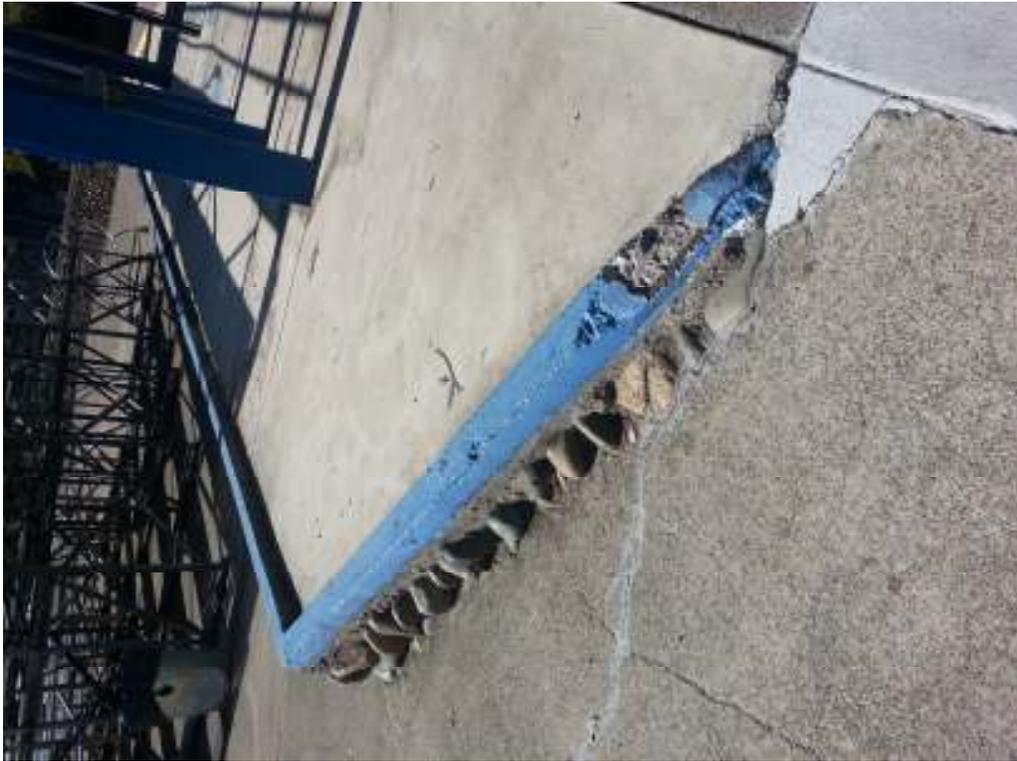
PP-11 Unprotected curb and ledge, Deck Cracks, Exposed Steel

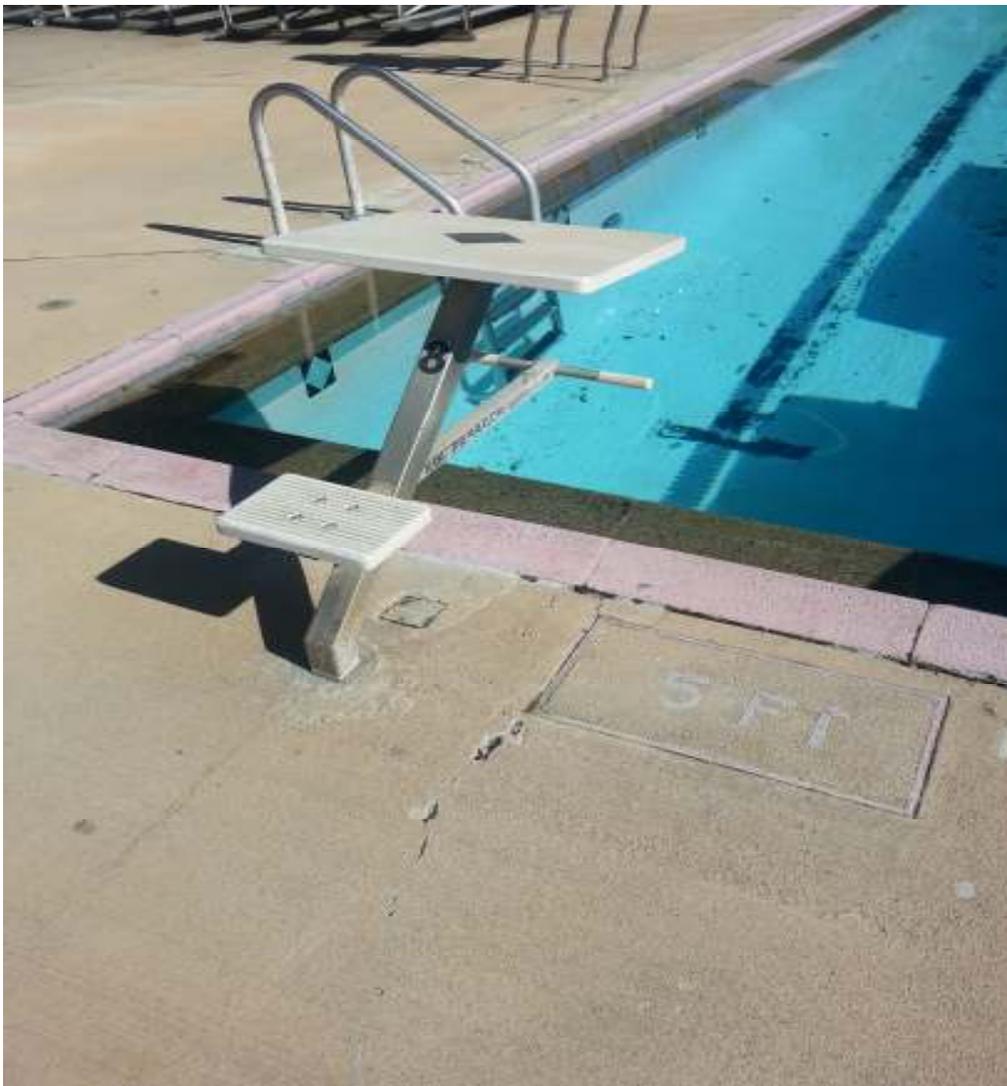
- K. The starting platforms are 30” off the pool water level and require a minimum of six feet of depth beneath them per industry standards and NHSA and NASO. These platforms are not covered and staff reports they are not removed during public swim. CHSC calls for racing lane platforms to be either removed or covered when not in use. PP-12

PP-12 Non-Compliant Starting Platforms, Deck Cracks, Faded Depth Markers

The two larges code-related issues are the non-compliant lifeguard stand and the competitive starting platforms. Both require replacement.

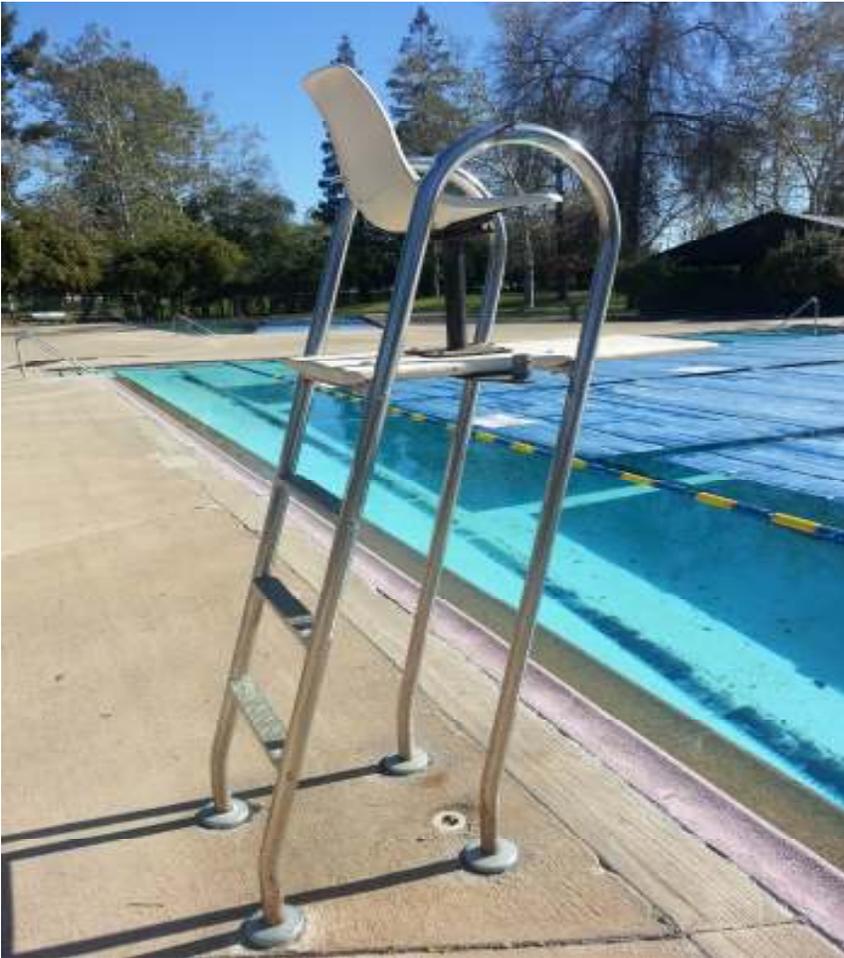
PP-13 Non-Compliant Lifeguard Stand

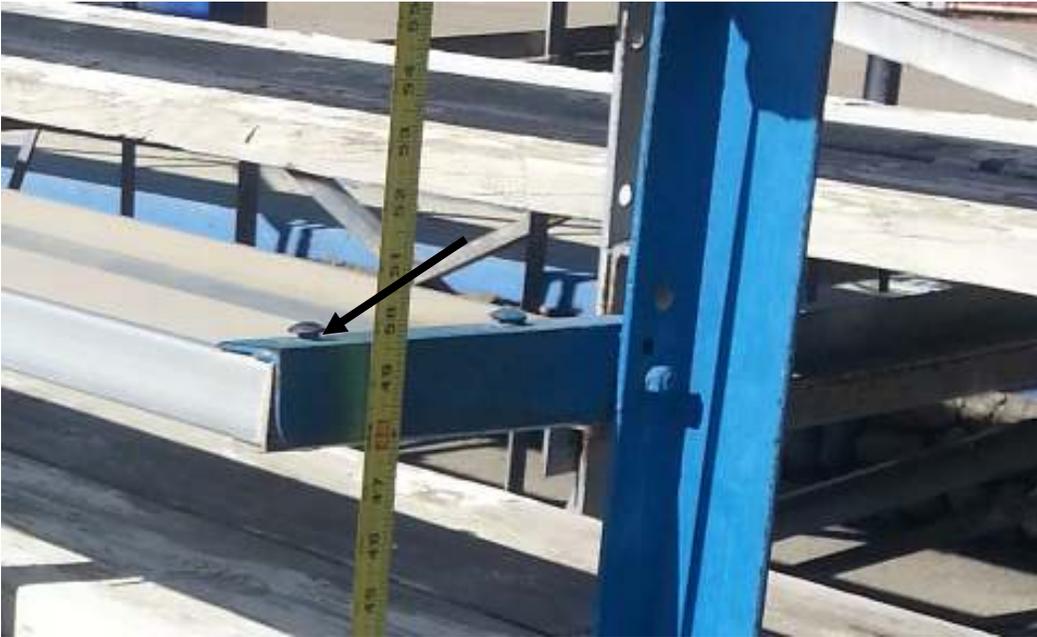
- M. The bleachers on the north side of the lap pool have bolts protruding above the bleacher seats that present a safety hazard and are not CPSC compliant. Other bleachers have wood seats and foot walks that have peeling paint and are unsightly. PP-14

PP-14 Bolts Protruding on Bleachers

-Repair to the bleacher bolt	Nominal
-Tighten the hand rail and replace escutcheons	\$ 200
-Install Hand rails on ledges and steps.	\$ 3,000

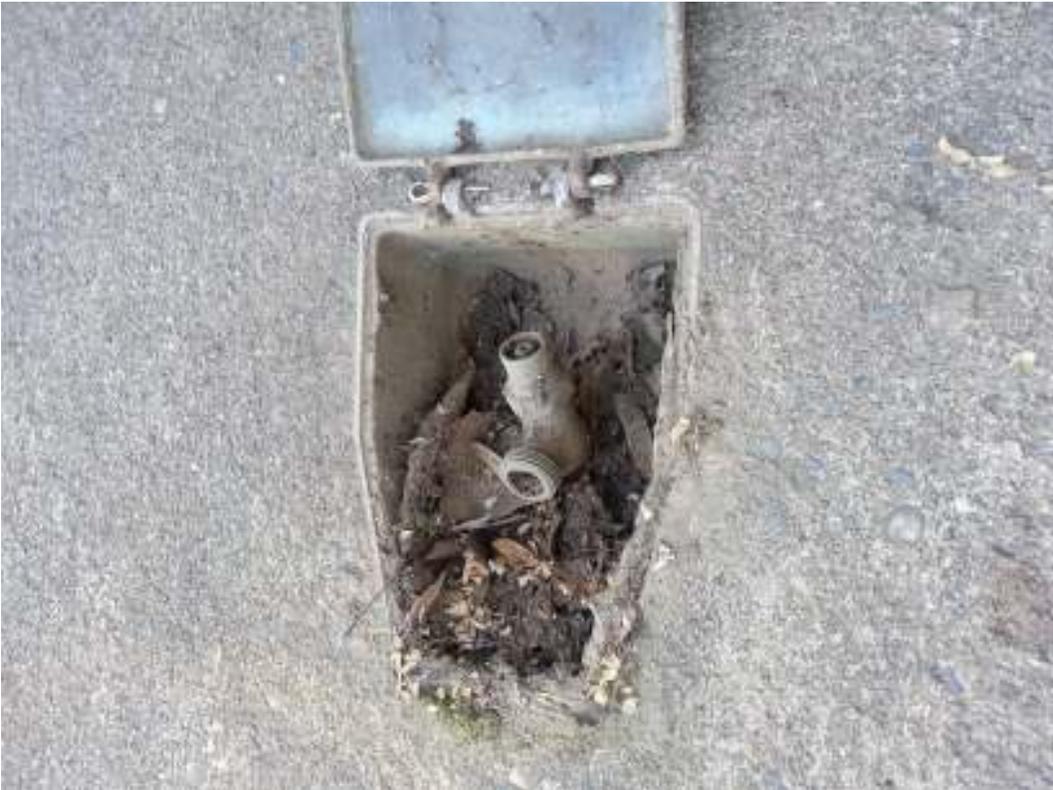
PP-15 Non-Compliant Hose Bibs (in deck)

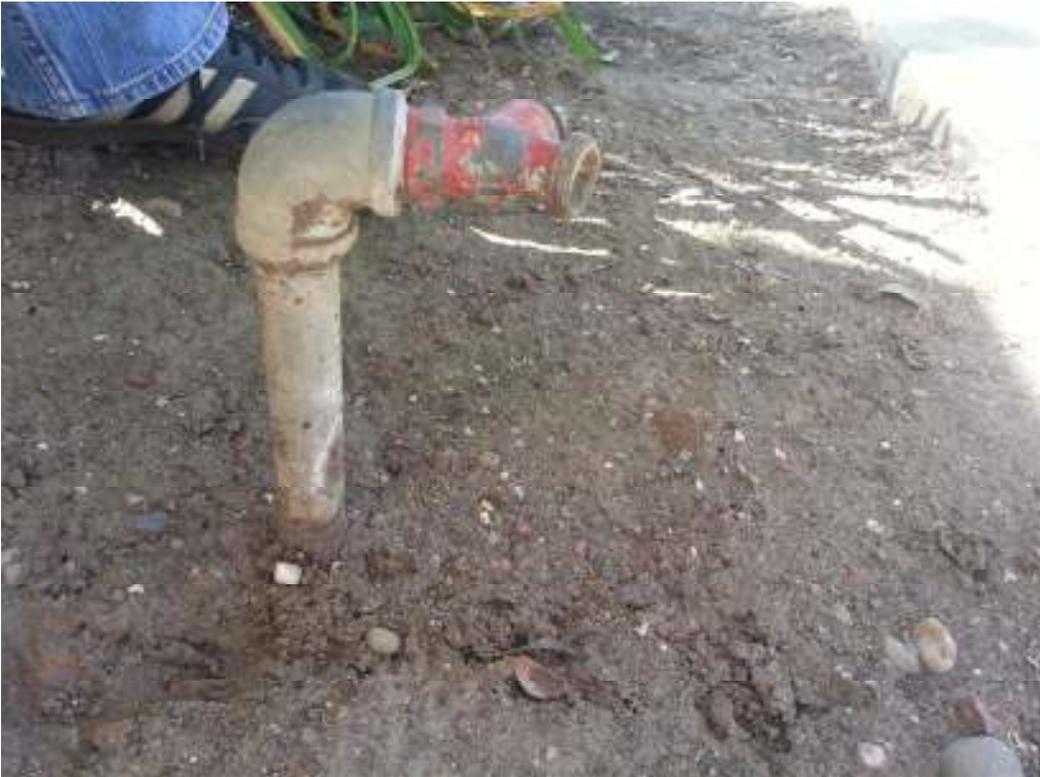
PP-16 Non-Compliant Hose Bibs

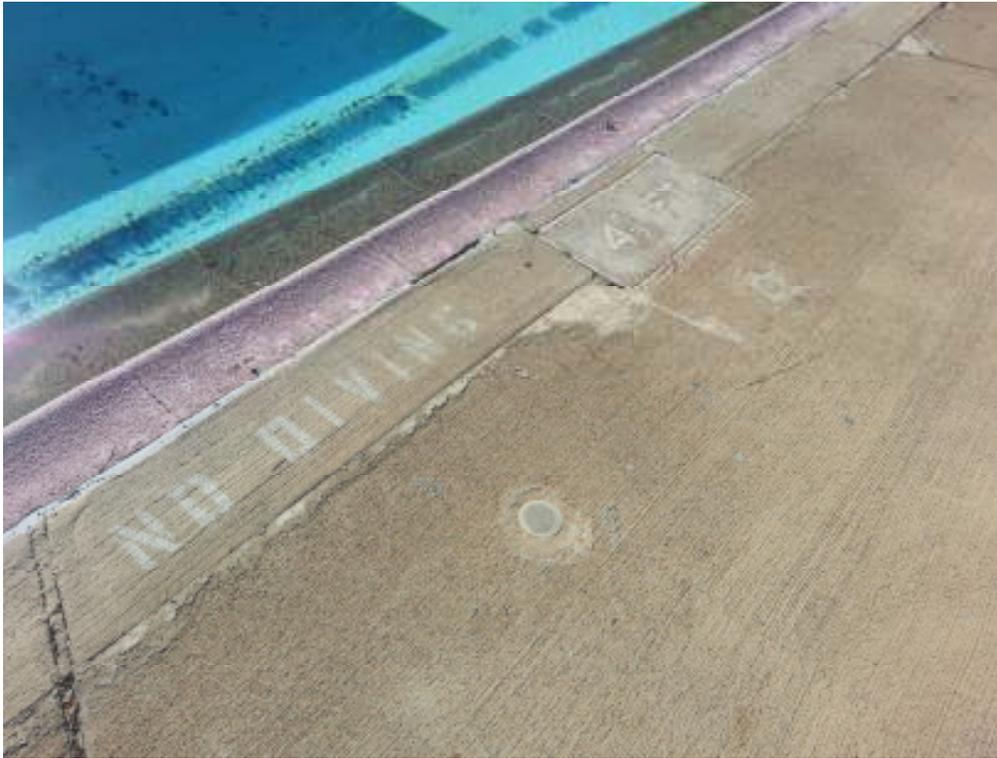
PP-17 Faded Deck Signage

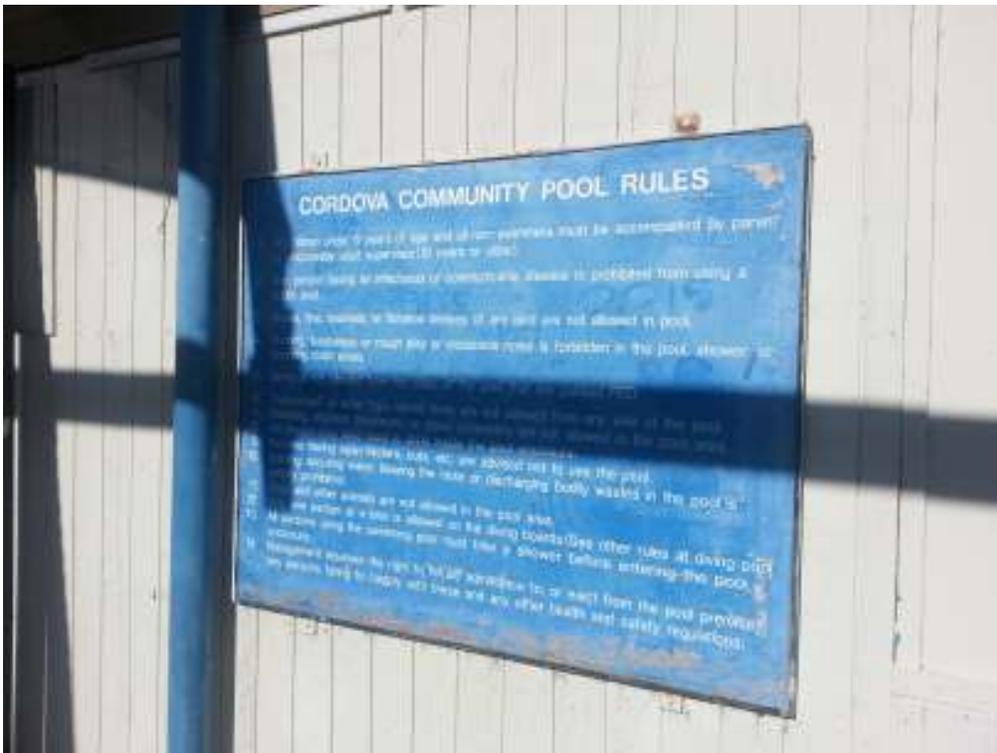
PP- 18 Faded Rules Sign

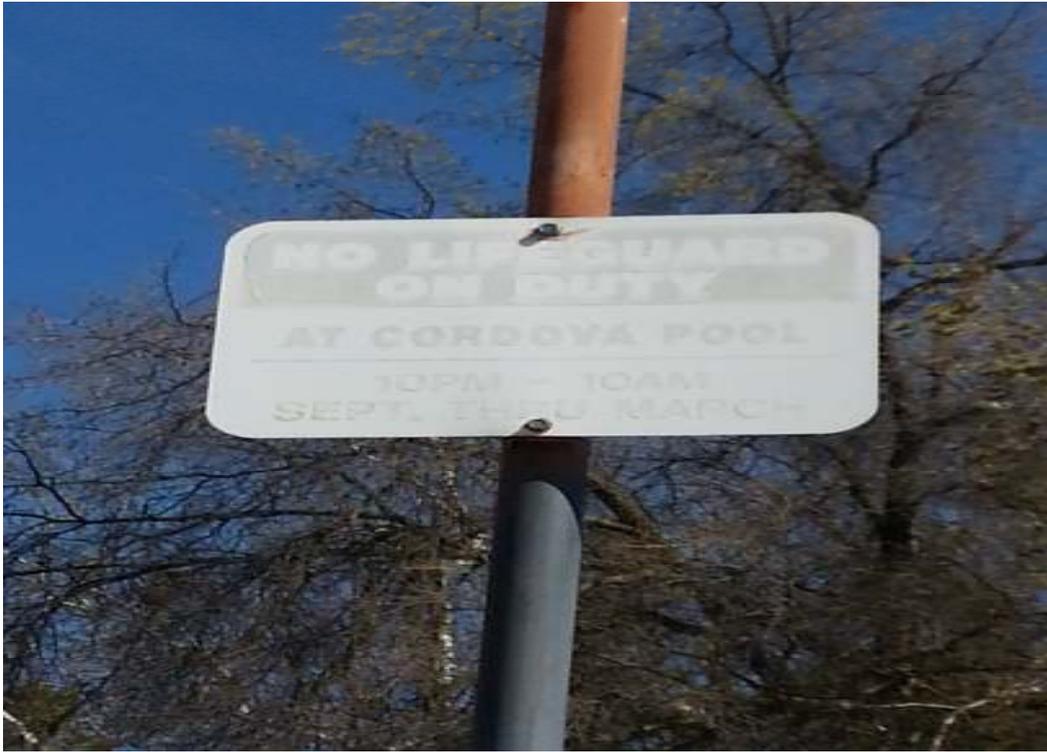
PP-19 Faded Safety Signs

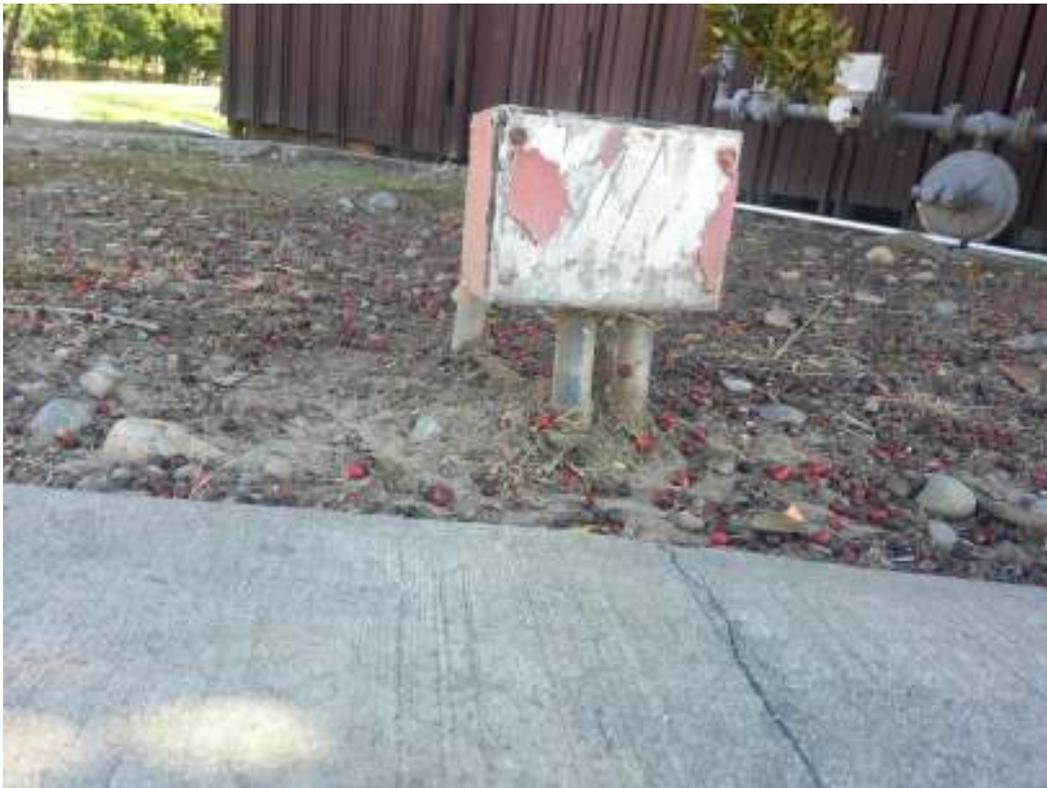
PP-20 Non-Compliant Pool Light Junction Box

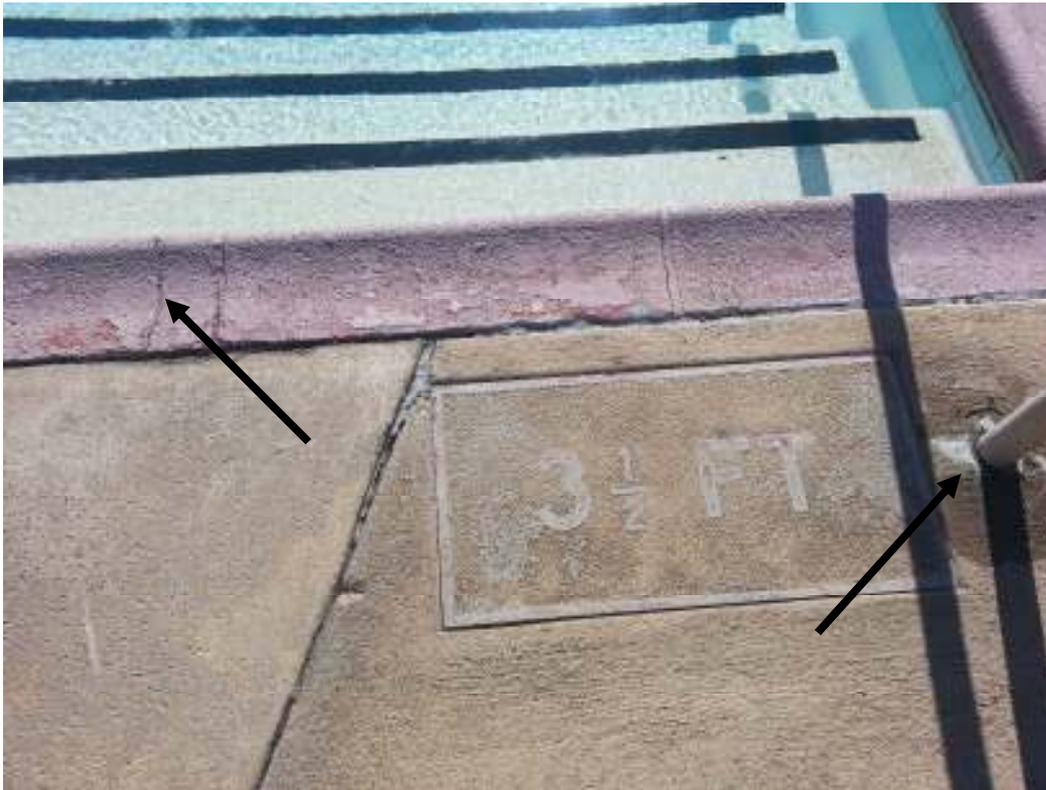
- Q. The ladder hand rails are missing the escutcheons that cover the wedge anchor. One rail is loose. PP-21
- R. The pool safety, information, emergency information and pool capacity signs are scattered around the pool deck rather than being posted in a conspicuous location near the entry. Most of the signs are faded. They do not comply with the CHSC.
- S. Overall the amount of shade for the deck is limited. (See also Section V Other Issues)
- T. The Handicapped lift meets the new Federal Disabilities Act, however, once the diving pool is opened and second lift will be required.

PP-21 Missing Escutcheon, Cracked Coping Stone, Faded Depth Marker

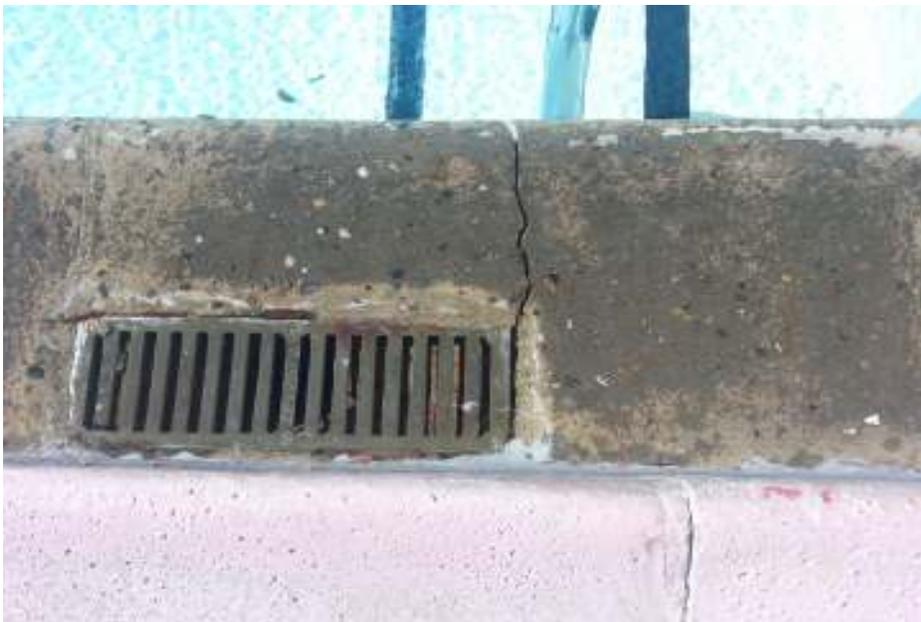
The “step-down” design falls is non-compliant with the CHSC and presents a trip hazard. There is a 4” elevation drop from the deck to the gutter edge. Several of the gutter stones are cracked PP-22, 23

PP-22 Gutter Configuration, Drain, Crack in Coping Stone

The non-compliant gutter configuration and design need to be replaced with a new gutter.

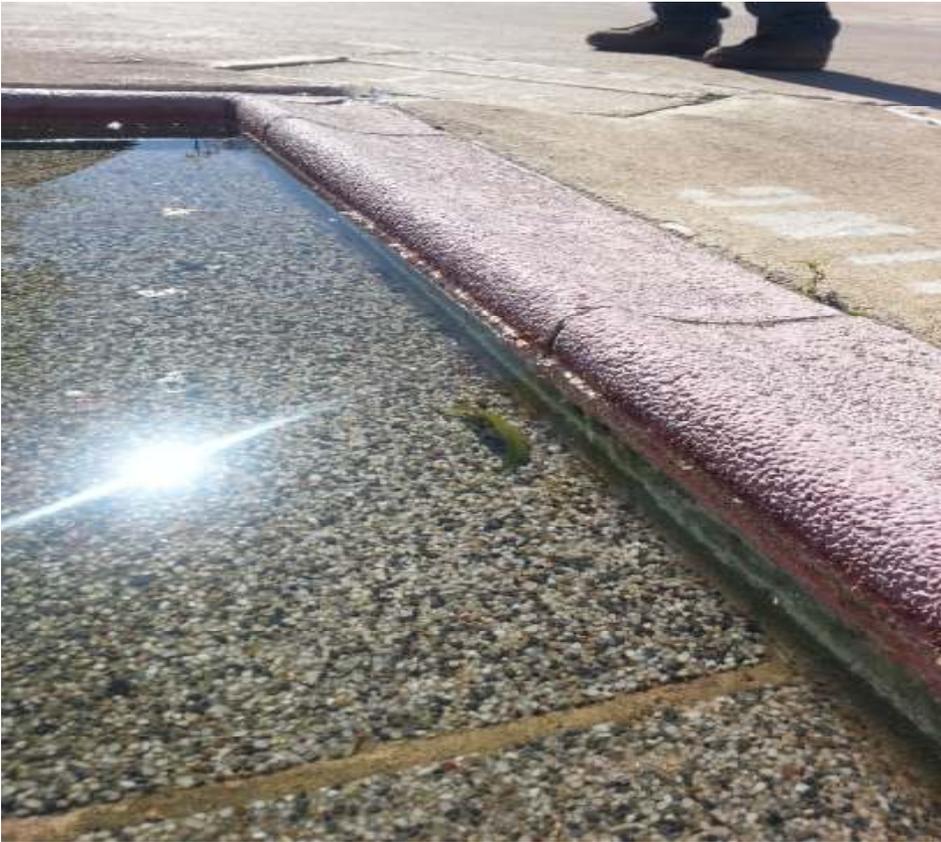
PP-23 Gutter Configuration “Step Down”

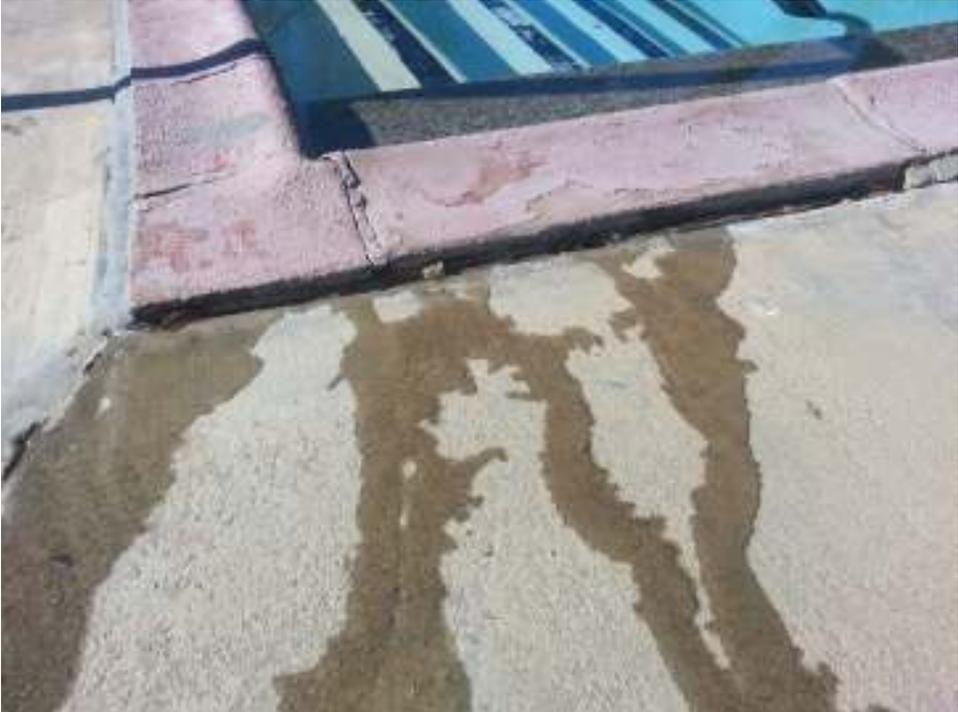
At the time of our inspection, it was evident water was leaking behind the gutter and onto the deck. I suspect, additional water is being lost through the various grout and caulk joints that make up the gutter. The gutter stones are well pitted and very rough,

PP-25 Pool Leaking Through Gutter

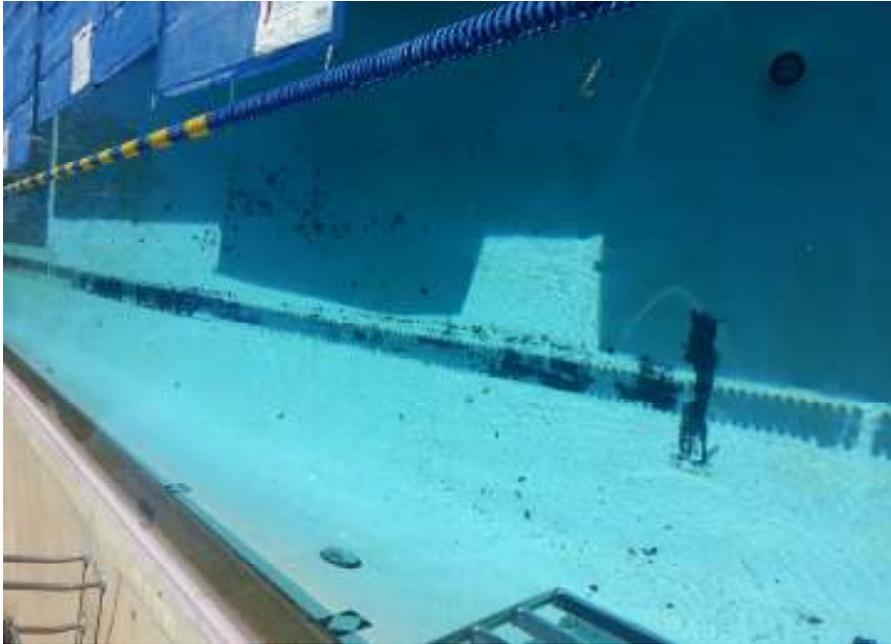
- B. Overall the interior fiberglass surface appears in reasonable condition, especially for being ten years old. However, the bottom racing lines on the lap pool are well faded and need replacement. NOTE: The photo was taken at a time when the shadow of the racing lane divider happened to fall on the bottom racing lane. The racing lane is almost completely gone) PP-26

PP-26 Faded Racing

Caulk cracks and seams in gutters:	\$2,000
Repaint lines and targets	\$3,000
Patch fiberglass tears	\$4,000

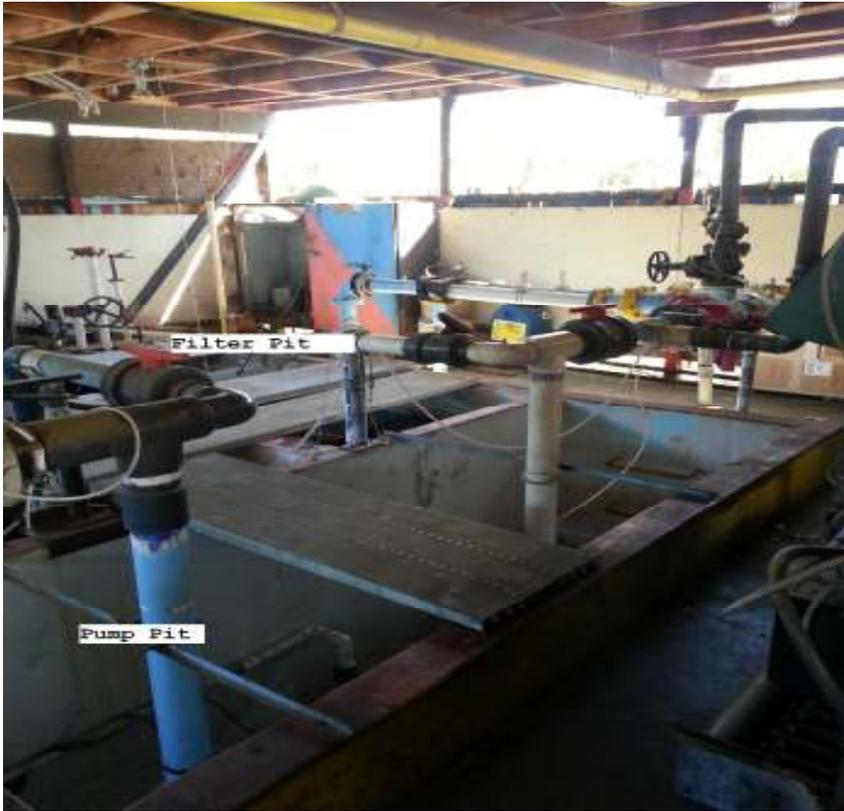
These are violations of the California OSHA and industry standards and present a significant safety hazard to staff. PP-27

PP-27 Filter Element / Pit / No Protective Railings / Unsecured Walkways

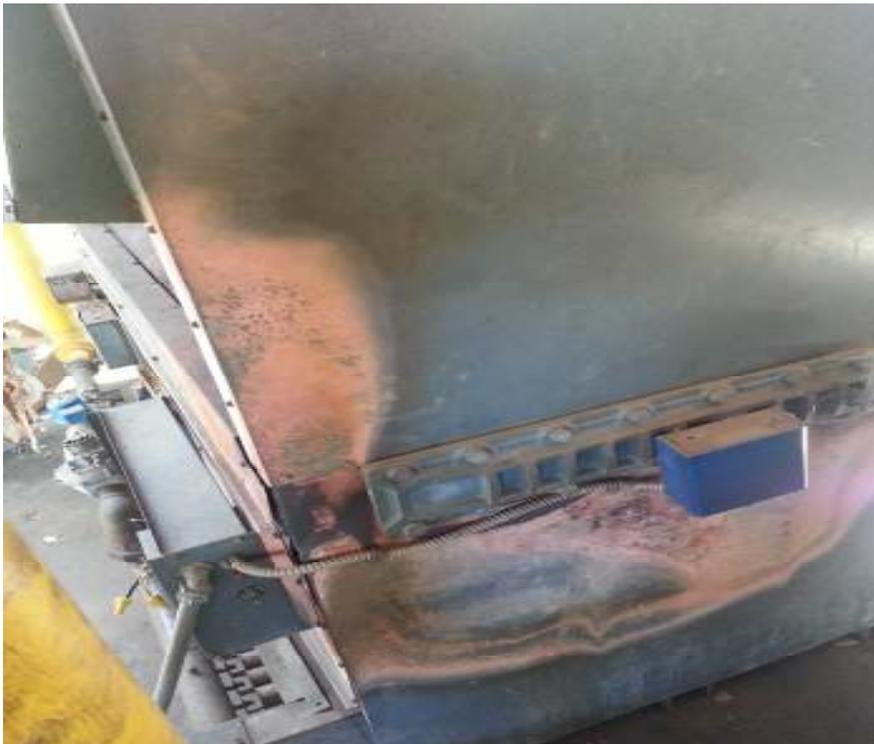
- D. The pool heater that was operating shows significant signs of overheating as the paint has peeled off and many wires are scorched. The maximum efficiency of this unit even when new was 78% and in its present condition probably closer to 60%. When the heater came on the heat radiating from the heater body was frightening. Many wires are exposed. PP-28, 29

PP-28 Overheated Pool Heater, Peeling Paint

The pool heaters are, as staff expressed, pretty much shot. Replacement with newer, more energy efficient units would be very cost effective. Three systems will be required, one for each pool.

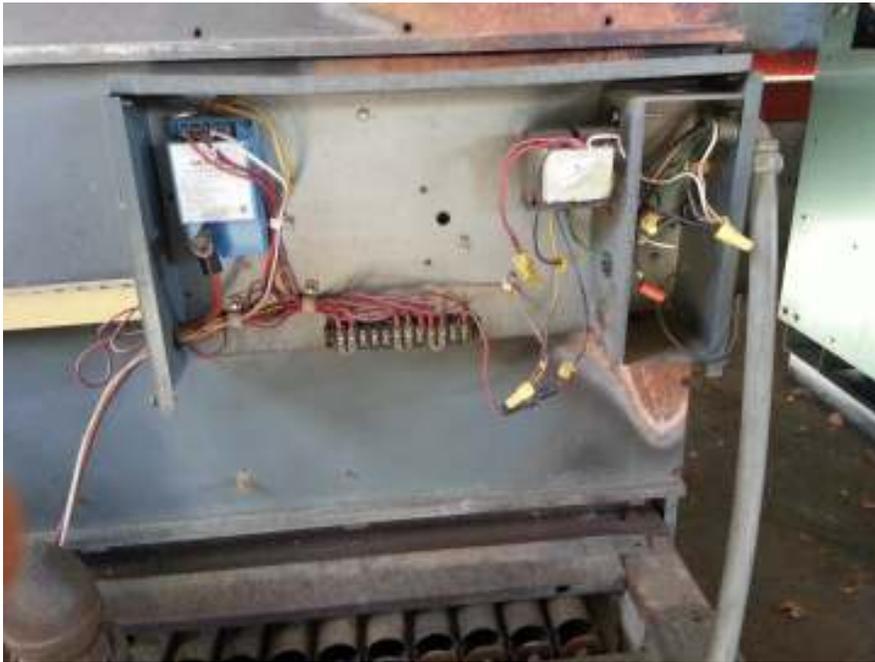
PP-29 Pool Heater Wiring

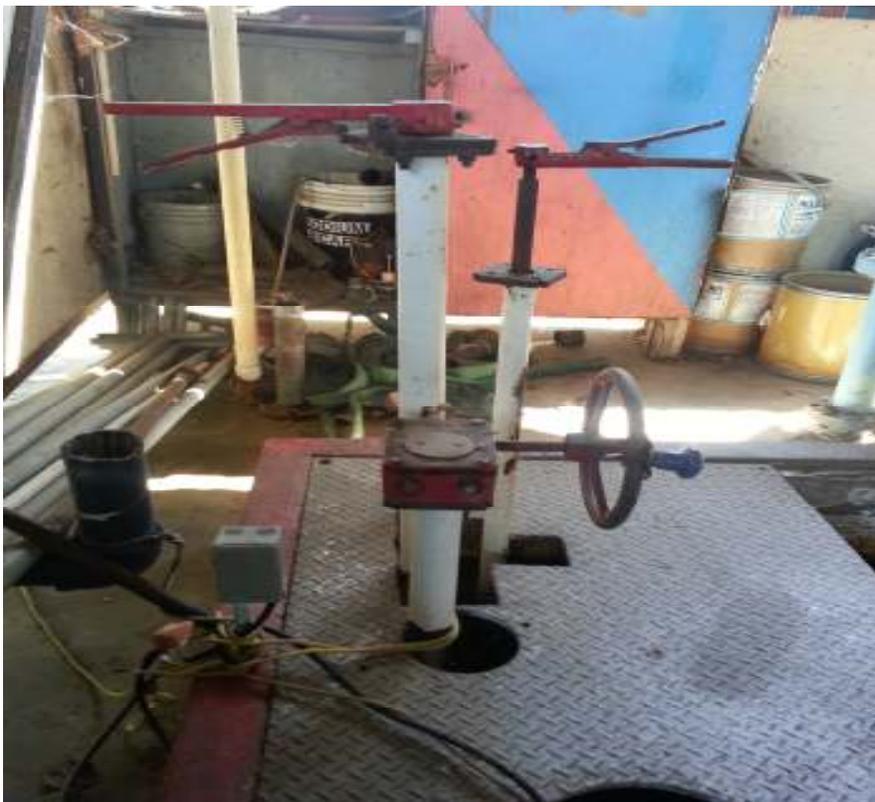
- E. The control valves for the surge/filter pit are not labeled and are significantly corroded and are fitted with various makeshift handles. Staff reports the valves are difficult to operate. PP-30

PP-30 Various Valve Handles and Corroded Extensions, No Labels
Un-kept Mechanical Room Floor
