Cordova, Recreation & Park District Cordova Community Pool Evaluation

May, 2014

*Prepared by:
Aquatic Commercial Consulting
Richard A. Young, Aquatic Consultant
800-660-5202 // richy@aquacom.us*

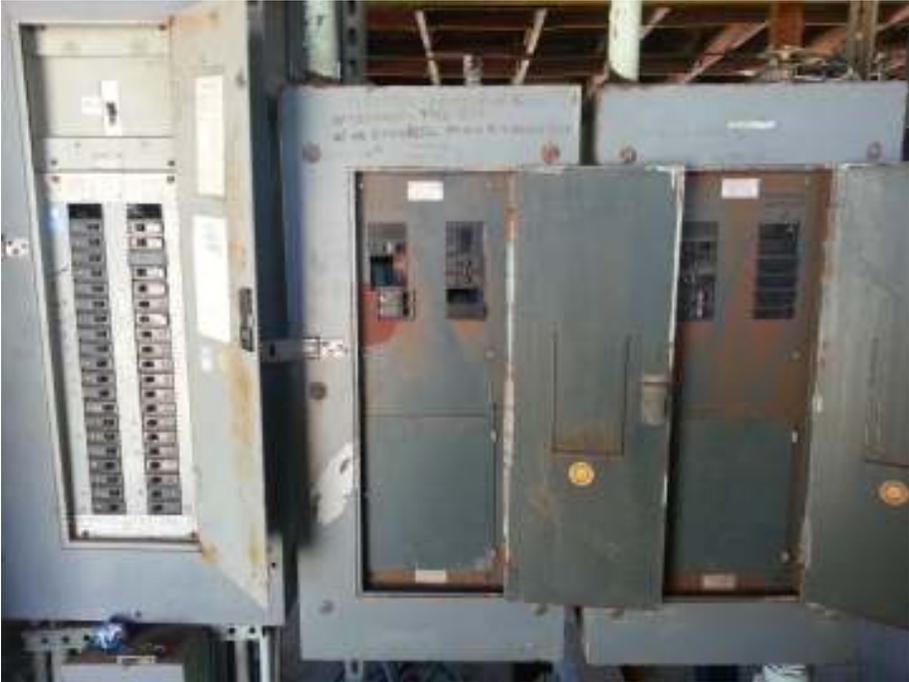
PP-31 Unlabeled Electrical Panels

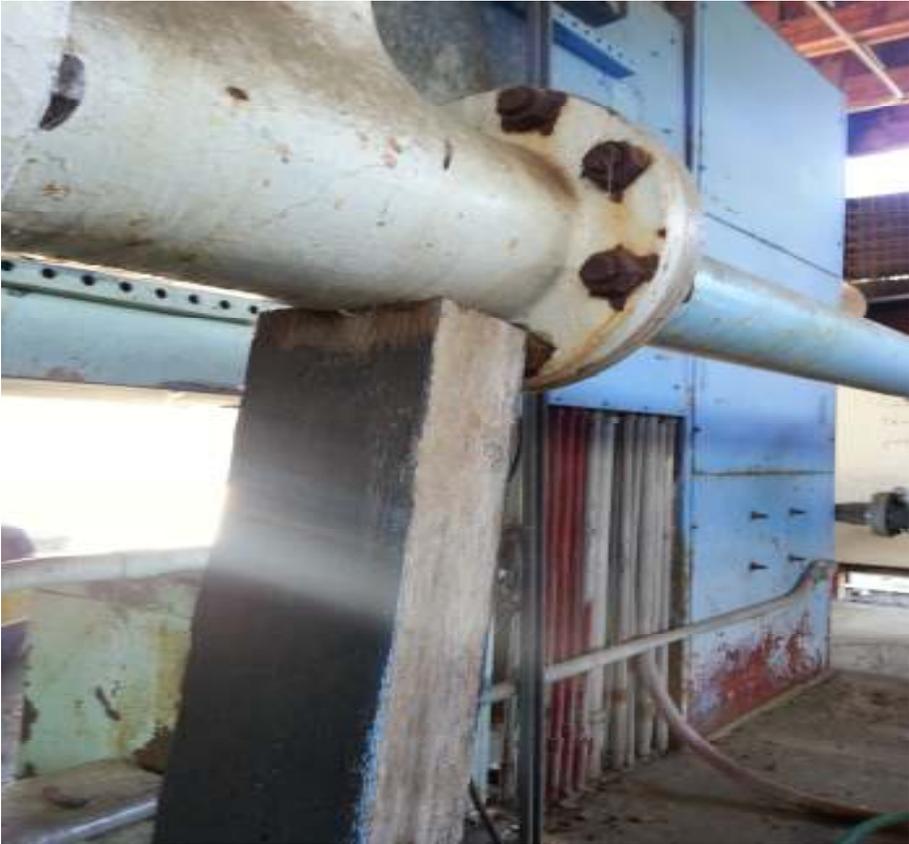
PP-32 Wood Bracing, Steel & PVC Pipe Sections

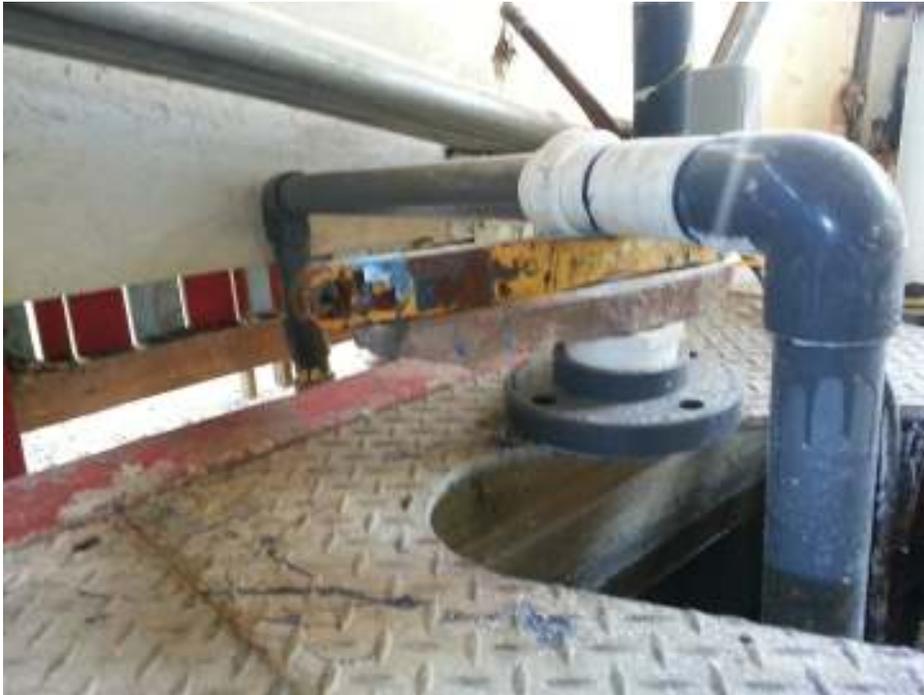
PP-33 Non-compliant Pipe Support

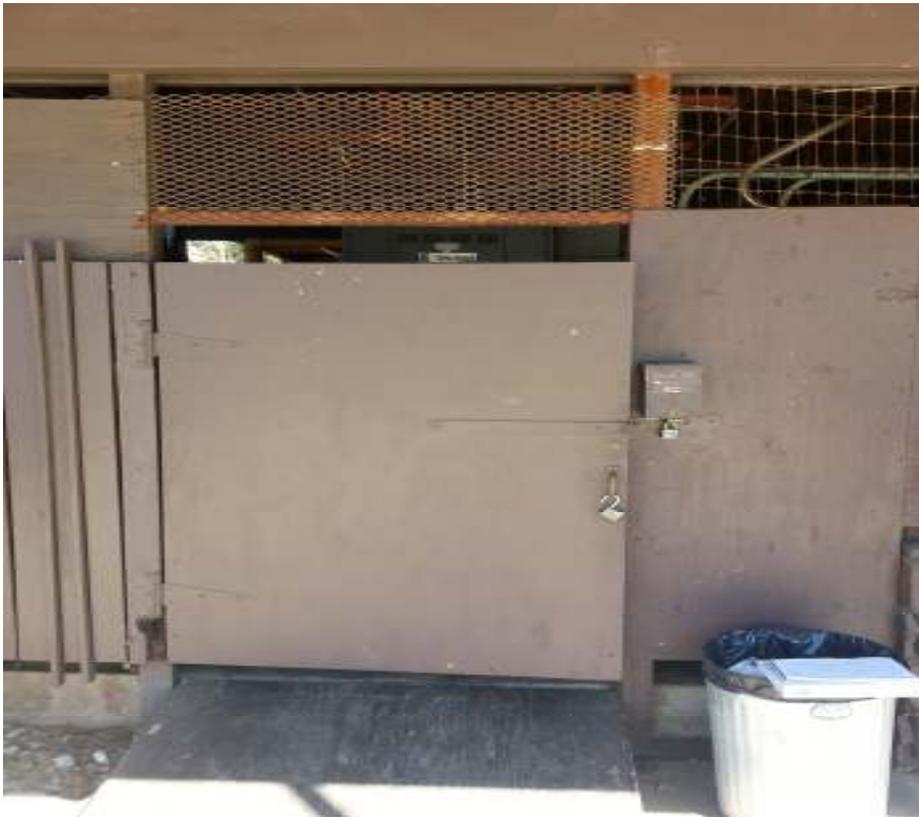
- K. The entry to the pool mechanical room does not have the OSHA and Article 80, Uniform Fire Code safety and warning placards on the door. PP-34
- L. The mechanical room building walls are a patchwork of cracked block wall, plywood, Boards and wire mesh, supported with 4 x 4 stanchions. PP- 34, 35

PP-34 No Safety or Warning Placards on Doors / Building Walls / Wood Ramp

In light of the condition of the pool mechanical room building, a new building should be constructed with seismically sound walls, proper access ramp. The building should enclose the gas lines now outside the mechanical room and exposed to patrons inside the pool enclosure.

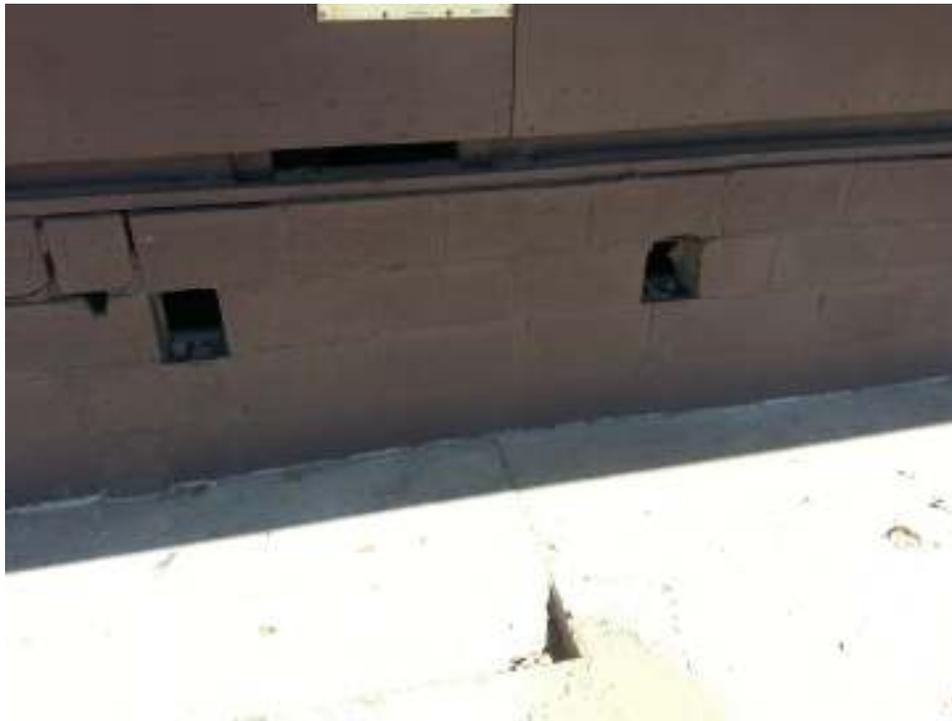
PP-35 Mechanical Room Building Wall

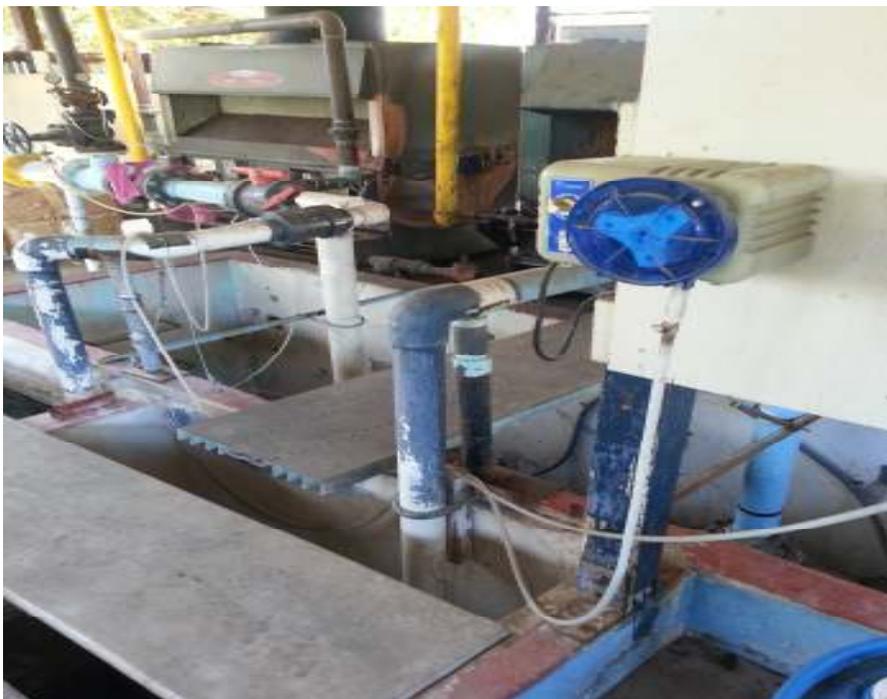
PP-36 Single Chlorine Feed Pump for Both Pools, unsecured, not double contained feed lines.

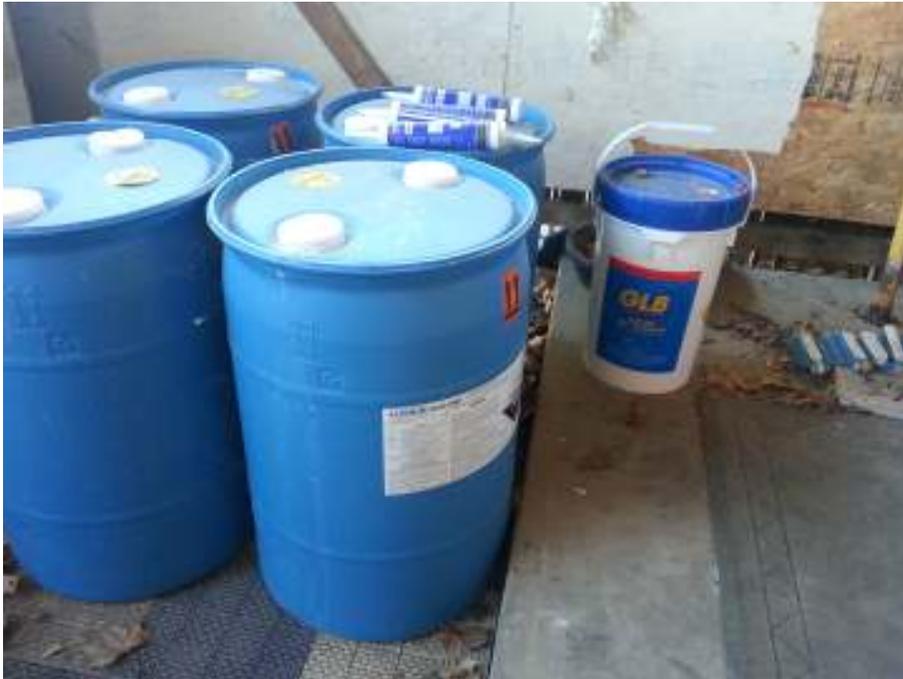
The chlorine (sodium hypochlorite, 12%) is fed from 52 gallon drums that are not double contained per Article 80, Uniform Fire Code. Other non-compatible chemicals are stored adjacent the chlorine contrary to Uniform Fire Code. PP-37

PP-37 Chlorine Barrels not double contained

unit with failsafe flow switch and memory:	\$4,000
-Provide separate containment pallets with a ramp for chlorine and acid storage.	\$ 800
-Install double containment for all chemical feed lines	\$ 200

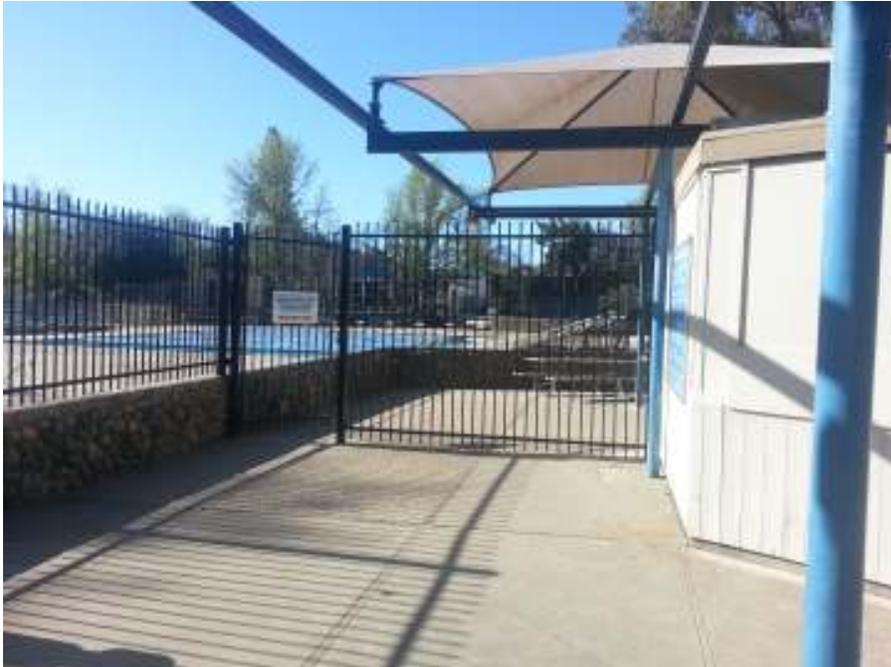
The existing entry is adequate but rather lack-luster and not very appealing to the eyes. There configuration does not lend itself for staff to greet patrons. The entry is not very secure as kids could sneak under the window and into the pool enclosure without being seen. The entry gate has several concrete cracks and patches. PP-38, 39, 40

PP-38 Entry Gate

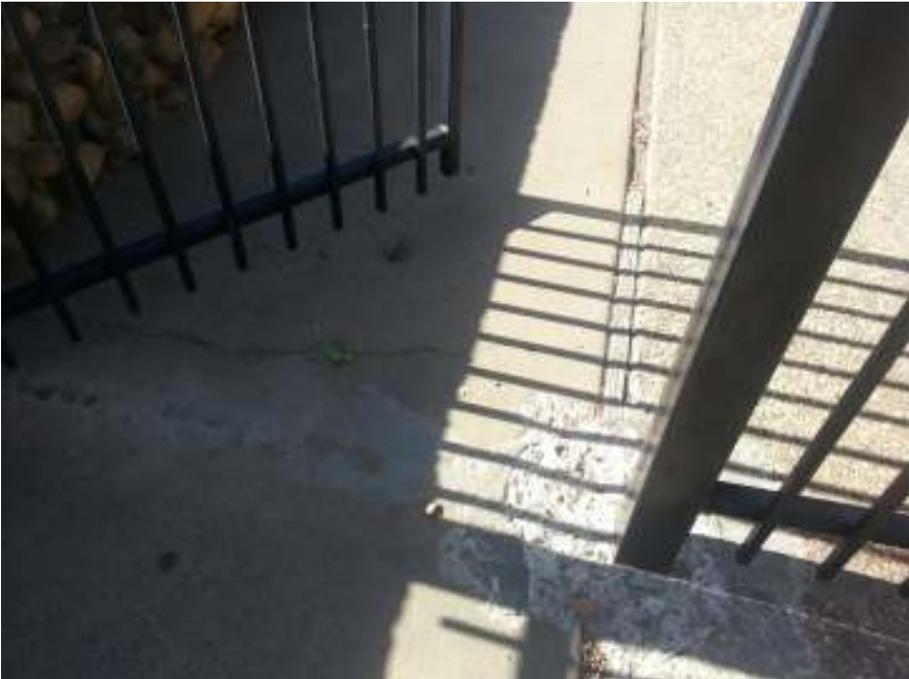
PP-39 Gate Deck Area Cracked and Patches

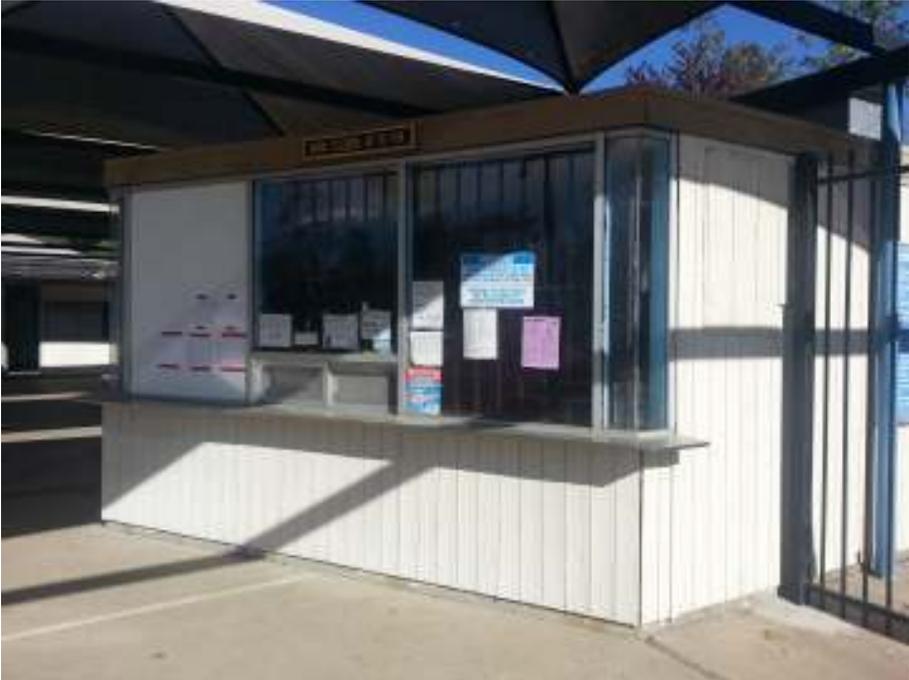
PP-40 Office Window
